A MITEL  
PRODUCT  
GUIDE

# Unify OpenScape 4000

Troubleshooting - AIFe

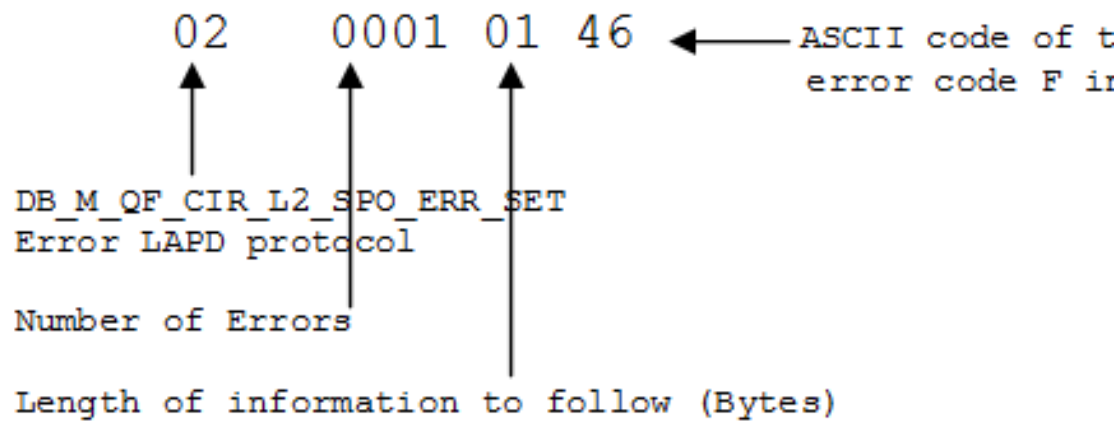
Table 29: Table II.1/Q.921 - Management Entity Actions for MDL-Error-Indications

Byte 4 is in fact the ASCII code of the error (character map under Windows can be used to convert this).

With the ASCII code, then look up the error in Table II.1/Q.921 and go from there:

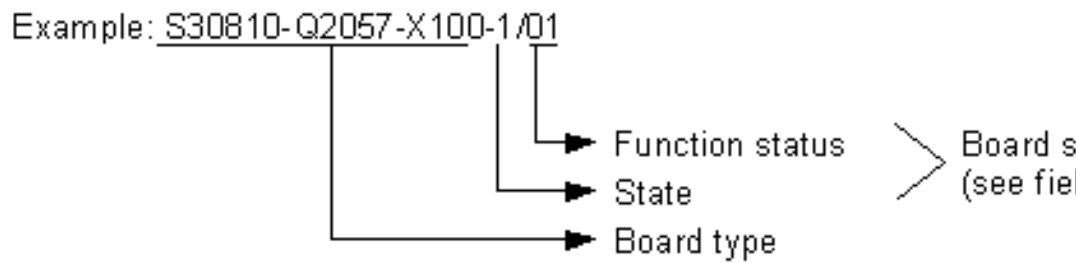
o Brd. ID in Part No  
(abbreviation of the parts list number)

The table for converting board type to board part number and vice versa is contained on the hard disk and must be loaded subsequently by the signaling task (SIT).

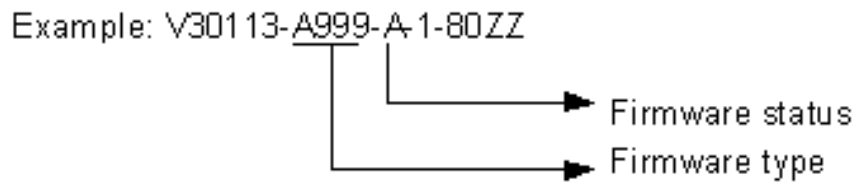
r Firmware ID (FW)

The *Firmware ID* consists of the 2nd and 3rd block of the master data name. It changes to the firmware status in correction versions.

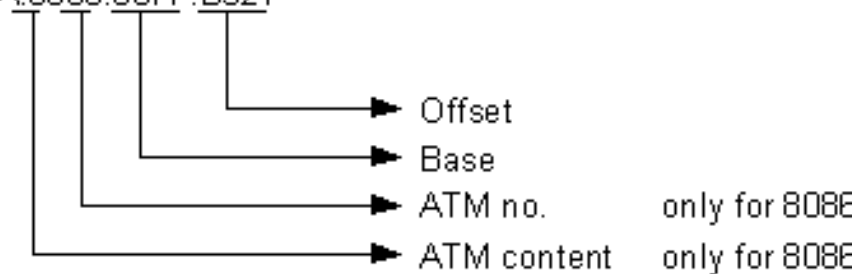
Signaling format:

Example: UA:0000:0877:B321

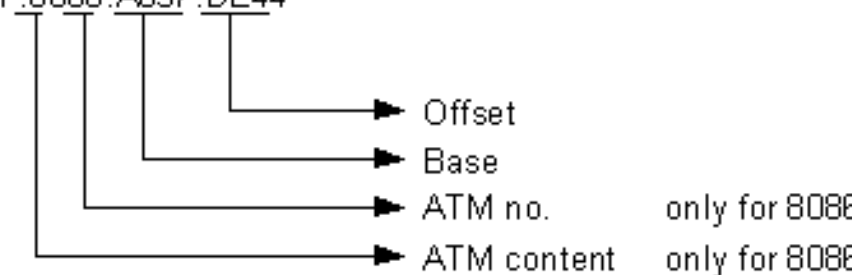
m STACK POINTER (ON\_M\_ADDRESS\_STR)

This data unit supplies the contents of the currently valid task stack pointer for OS-CALL errors.

Signaling format:

Example: SP:0000:A657:DE44
